Lower Williamson River Floodplain and Delta Restoration: Hydraulic Modeling

Prepared by
US Department of the Interior
Bureau of Reclamation

March 2004

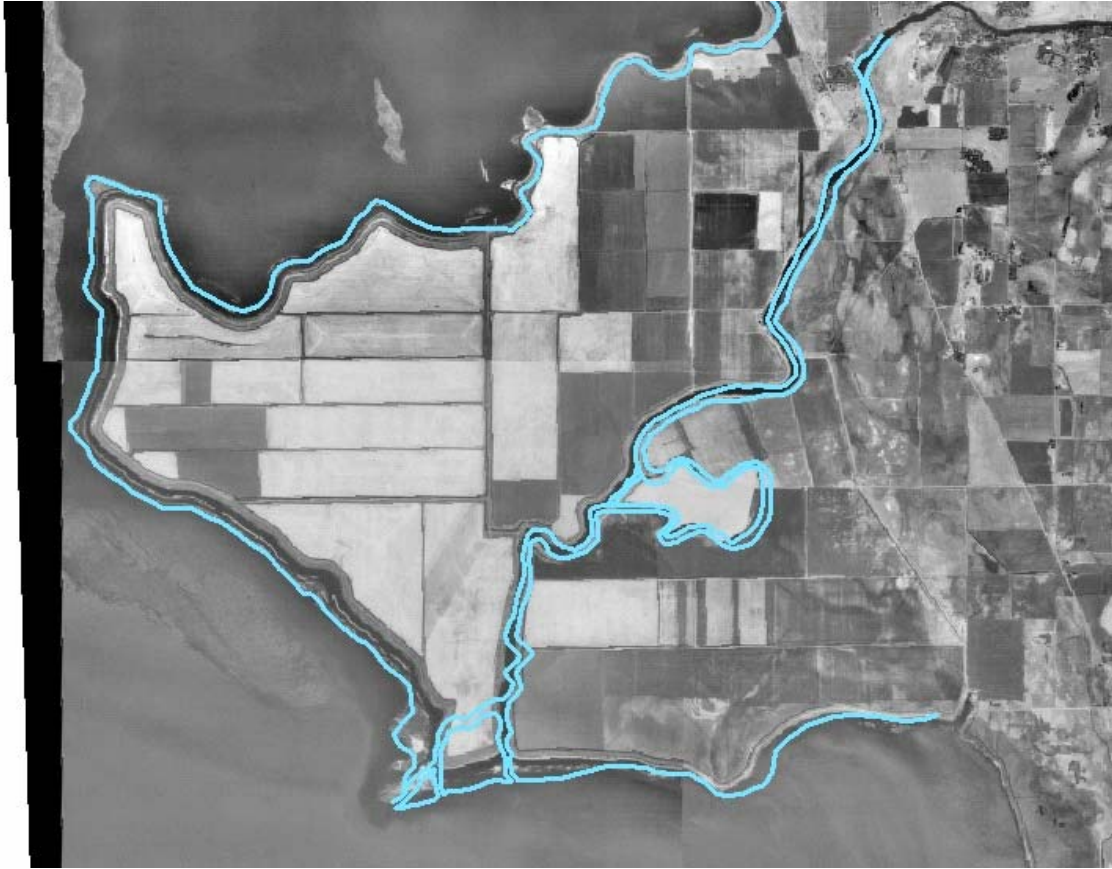
Figure 12. River alignment and shoreline (blue) from 1940-41 aerial photographs superimposed onto the 1996 aerial photograph.

Figure 12 is a more recent aerial photograph of the area, circa 1996, with the alignment of the river channel from the 1940-41 photographs superimposed upon it. Figure 12 shows that the existing alignment is very similar to the alignment observed in the 1940-41 aerial photographs with the exception of the present cutoff of the oxbow by levees, and at the river mouth.

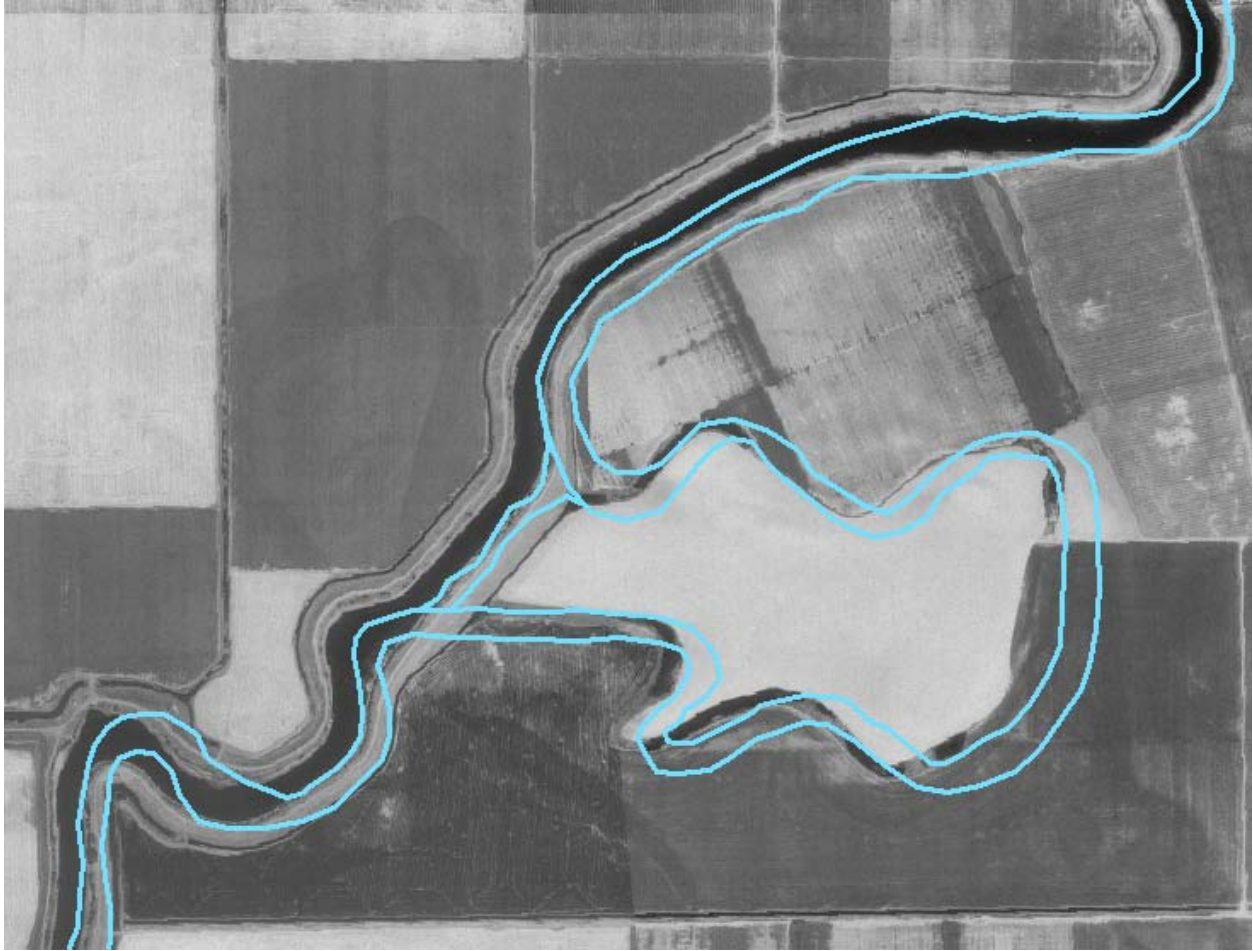
Figure 13. Oxbow reach of the study area showing the 1940-41 alignment (blue) over the 1996 aerial photograph.

Figure 13 shows a zoomed in view of the oxbow area with the 1940-41 alignment superimposed on the 1996 photo. It is clear that the old oxbow, now cut off from the main channel by levees, matches the 1940-41 alignment fairly well. Presently, the oxbow channel is filled in with sediment and is much narrower and shallower than it was in 1940-41. This area would need to be excavated (i.e., made deeper and wider) in order to restore the channel to conditions found in 1940-41. It is interesting to note that an initial cutoff channel of the oxbow can already be seen in the 1940-41 aerial photographs. It is not known if this was natural or if the cutoff channel had been mechanically excavated.

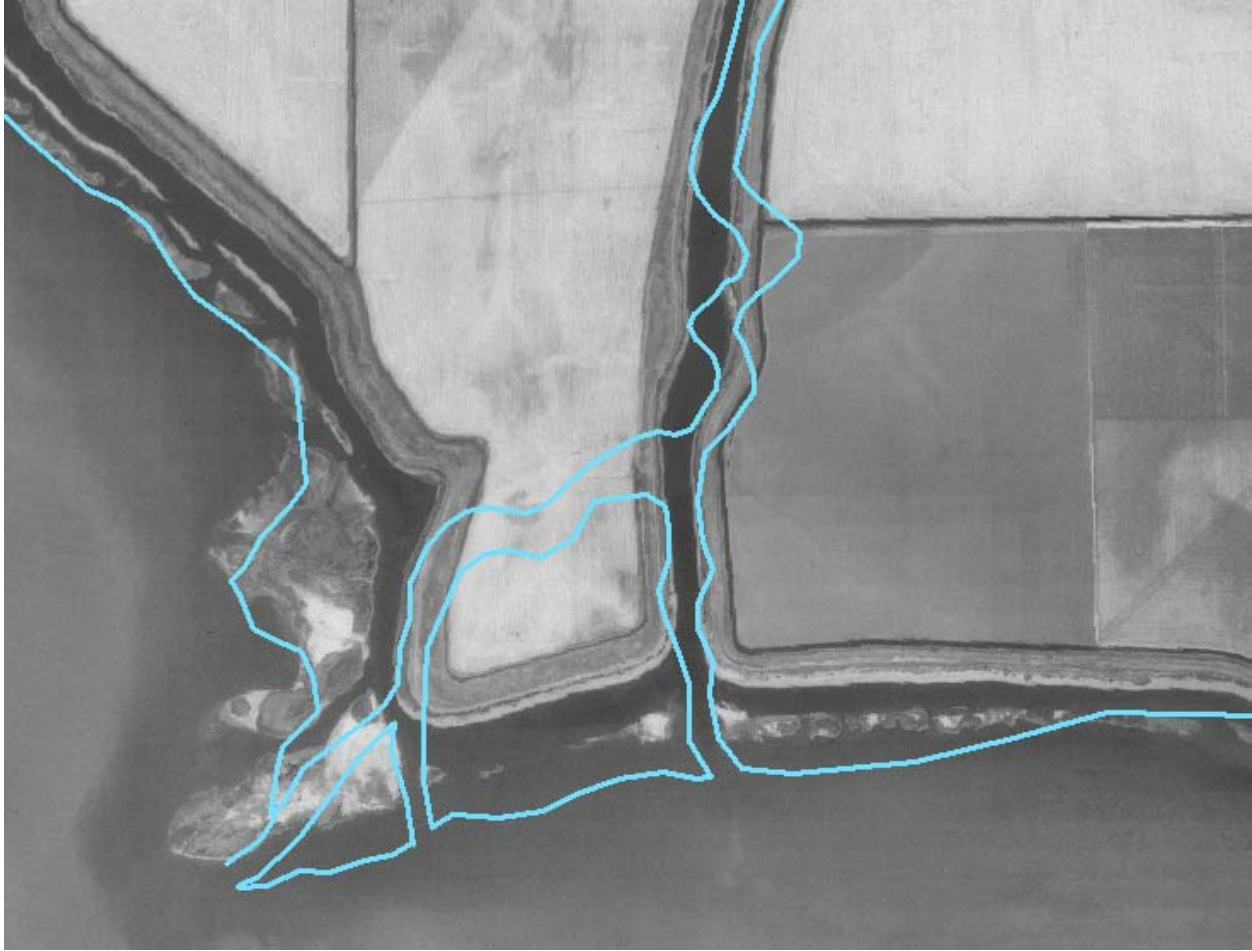
Figure 14. River mouth reach of the study area with the 1940-41 alignment (blue) over the 1996 aerial photograph.

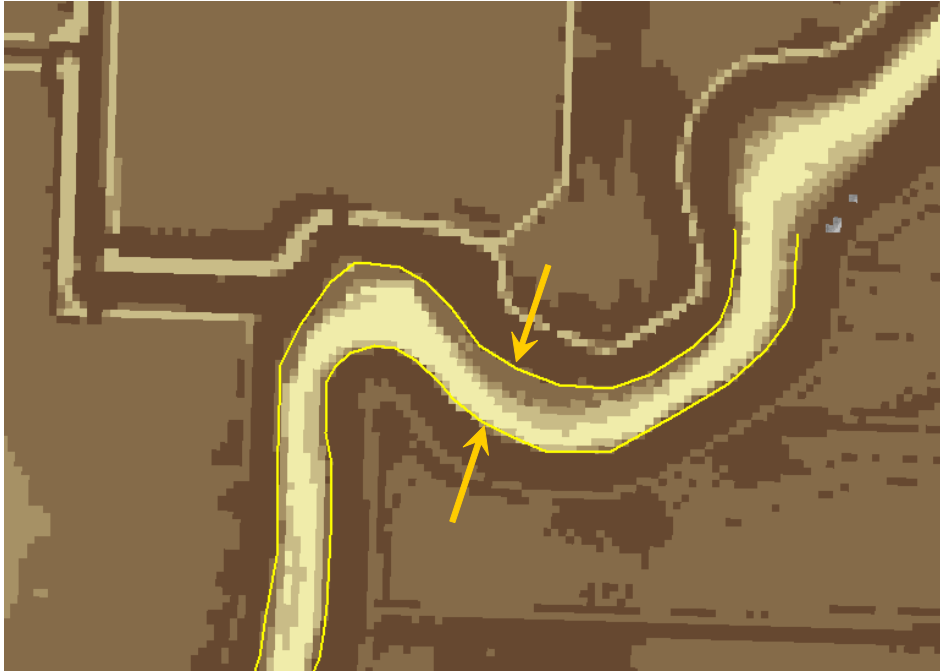
Figure 38. Yellow lines highlight the existing channel width in a reach of the river just downstream of the oxbow.

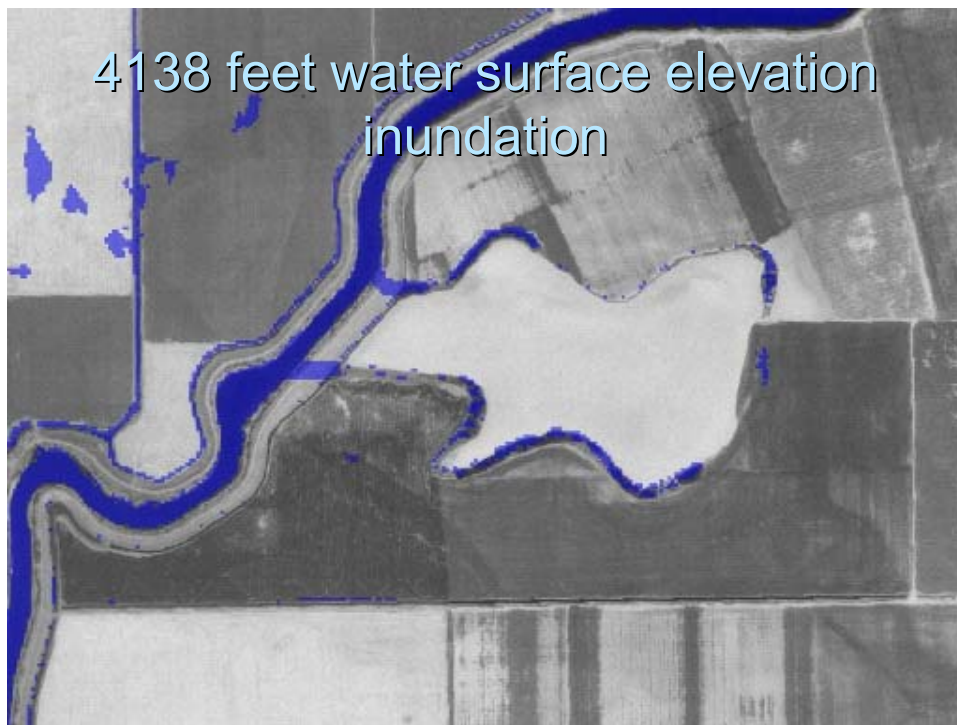
Figure 57. Inundation map of the oxbow channel. Blue shows area of inundation with a lake water surface elevation of 4138 feet. Inundation is shown with the simulated removal of levees including breaching to an elevation 4136 feet at the entrance and exit to the oxbow channel.
